**SPE 142121**

## **Structural Integrity and Life Extension of Offshore Installations by Ultrasonic Peening**

Luis Lopez Martinez/LETS Global

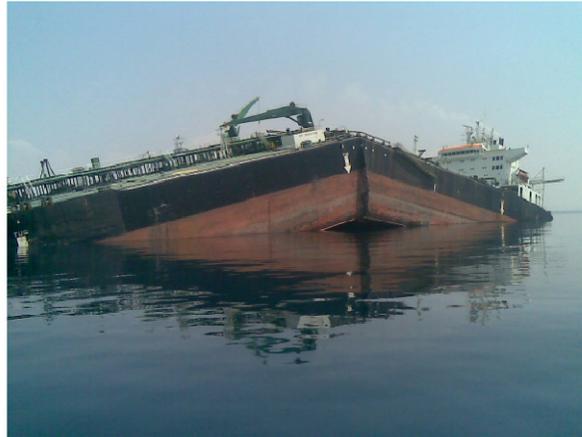
**Fig 1 Structural integrity failure [1]**

However, it should be clear that small fatigue cracks which occurs simultaneously at several locations in the hull and keep developing would have a negative influence on the structural integrity sooner or later, Fig 1.

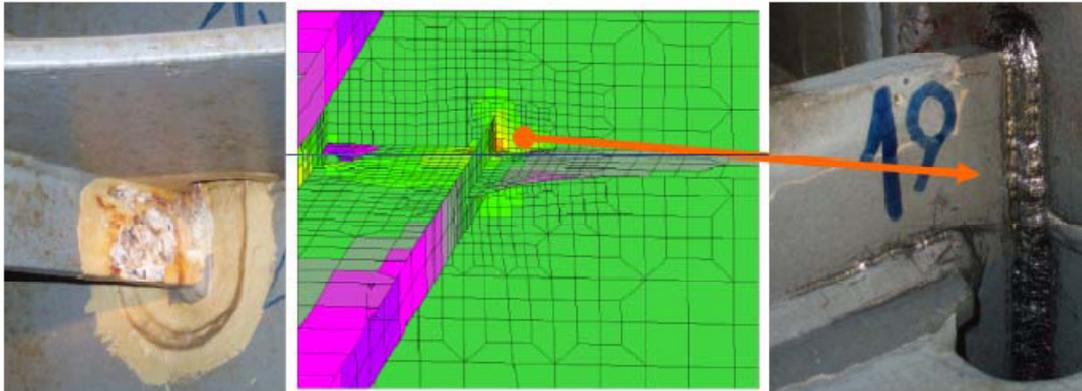
Other sensitive parts located by the hull strength analysis are weld connections at transverse bulkheads. Similarly as for the weld connections from web frames the bulkheads connections to longitudinal are sensitive to loads arising from the horizontal bending moment. As a result the inner bottom longitudinal and the stringer toes and heels showed too short fatigue lives. This connection is shown in Fig 3. We include the inspection picture, the FEA local model and the result of the ultrasonic peening treatment of the location.

**Fig 3 Area inspected, modeled and treated by ultrasonic peening [3]**

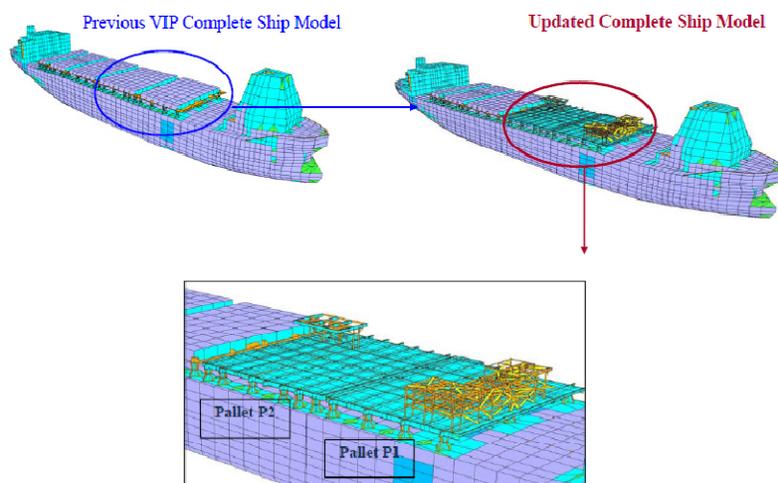
The production equipment on FPSO Triton is located on the topside and the supporting steel structure is connected to the cargo deck via the pallet stools brackets and its welds, Fig 4. The equipment supporting structure and its mass are considerable more rigid than the hull itself. As a result of this difference in flexibility the weld connections joining the pallet stools to cargo deck experiences high level of stresses. Hence and due to these high stresses relatively low fatigue life was expected. Furthermore it is likely that more equipment will be needed in a near future and therefore more weight will be added to the current supporting structure.

**. Fig 4 Detail studies of the pallet stool structure [1]**

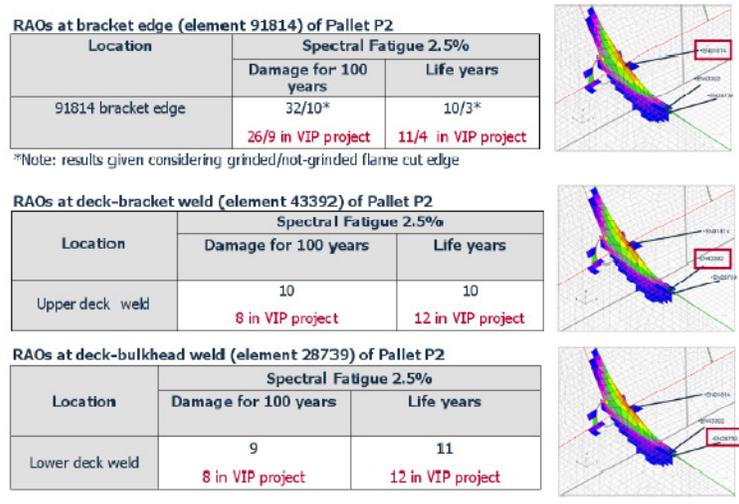
In the new hull strength analysis the additional equipment on the topsides has not shown any impact on the fatigue results. However the fatigue strength is determined by the connection design as well as by its weld quality. As showed in Fig 5 the areas of major concern are the welds on the toes and on the side of the brackets. The brackets and welds transfer all the weight from topside structure to the longitudinal bulkhead via the pallet stools.

Fig 5 Fatigue results of top load effects on stool toes [1]

As presented in Fig 5 the major concerns arise from the welds on the toes and the sides of the brackets to cargo deck. Furthermore these welds have shown some varying weld quality which by itself could influence the fatigue strength negatively. Therefore these weld connections, have been considered for the application of the ultrasonic peening treatment.

The intention with the ultrasonic peening treatment is to avoid any further weld repair on these weld details during the remaining service life of the installation.
