**SPE 142121**

## **Structural Integrity and Life Extension of Offshore Installations by Ultrasonic Peening**

Luis Lopez Martinez/LETS Global

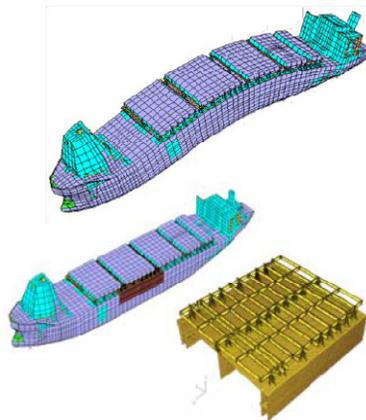
The full ship or hull strength analysis is the starting point of any Life Extension Study. Therefore special attention must be paid to its accuracy as well as the analysis of its results. Normally it would be carried out by experienced specialist. The example presented in this report has been carried out by Bureau Veritas. Fig 1 shows a typical load case for the hull, vertical bending moment, and its influence on the pallet stools and hence on the structural integrity of the vessel.

**Fig 2 From full ship analysis to local stress analysis (Courtesy of Bureau VERITAS)**

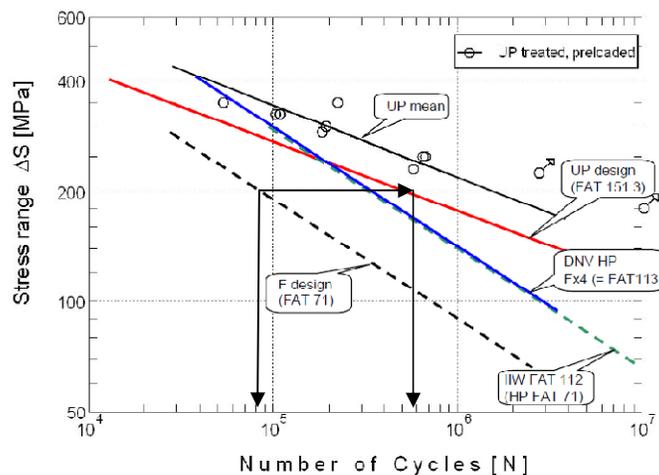
The degree of fatigue life improvement achieved by the ultrasonic peening treatment is illustrated by the diagram in Fig 6. If we assume a stress range of 200 MPa the number of loading cycles can be increased from  $80 \cdot 10^3$  up to  $550 \cdot 10^3$  for same 2.5% fatigue crack probability. That is a fatigue life extension of more than four times due to the ultrasonic peening treatment.

Fig 6 Fatigue life extension achieved by ultrasonic peening [4]

The redistribution of tensile residual stresses originated during and after welding procedure interacts with the compressive residual stresses induced into the HAZ during the ultrasonic peening treatment. This is illustrated in Fig 6 by the different slope for untreated respective treated welds. The redistribution of residual stresses, including the introduction of compressive stresses, contributes towards fatigue life extension by locally lowering the mean stress.

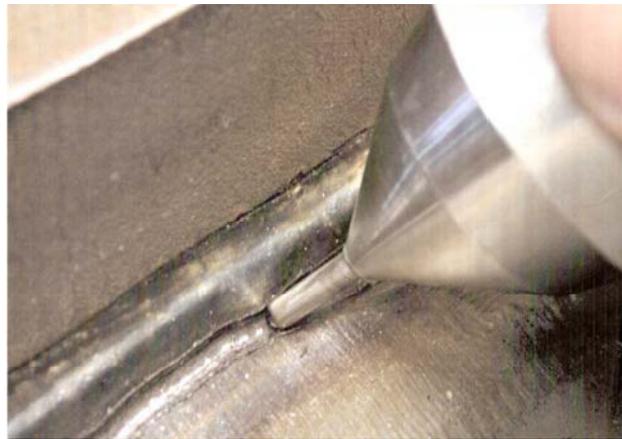
These three features are modified by ultrasonic peening treatment in one and solely working operation. The creation of a groove at the weld toe eliminates any weld toe defect and decreases the local stress concentration, Fig 7.

**Fig 7 Creation of weld toe groove during ultrasonic peening treatment [4]**
